Delivery Order 9 Enhanced Preliminary Assessment

FORT DEVENS, MASSACHUSETTS

April 1992

ENHANCED PRELIMINARY ASSESSMENT

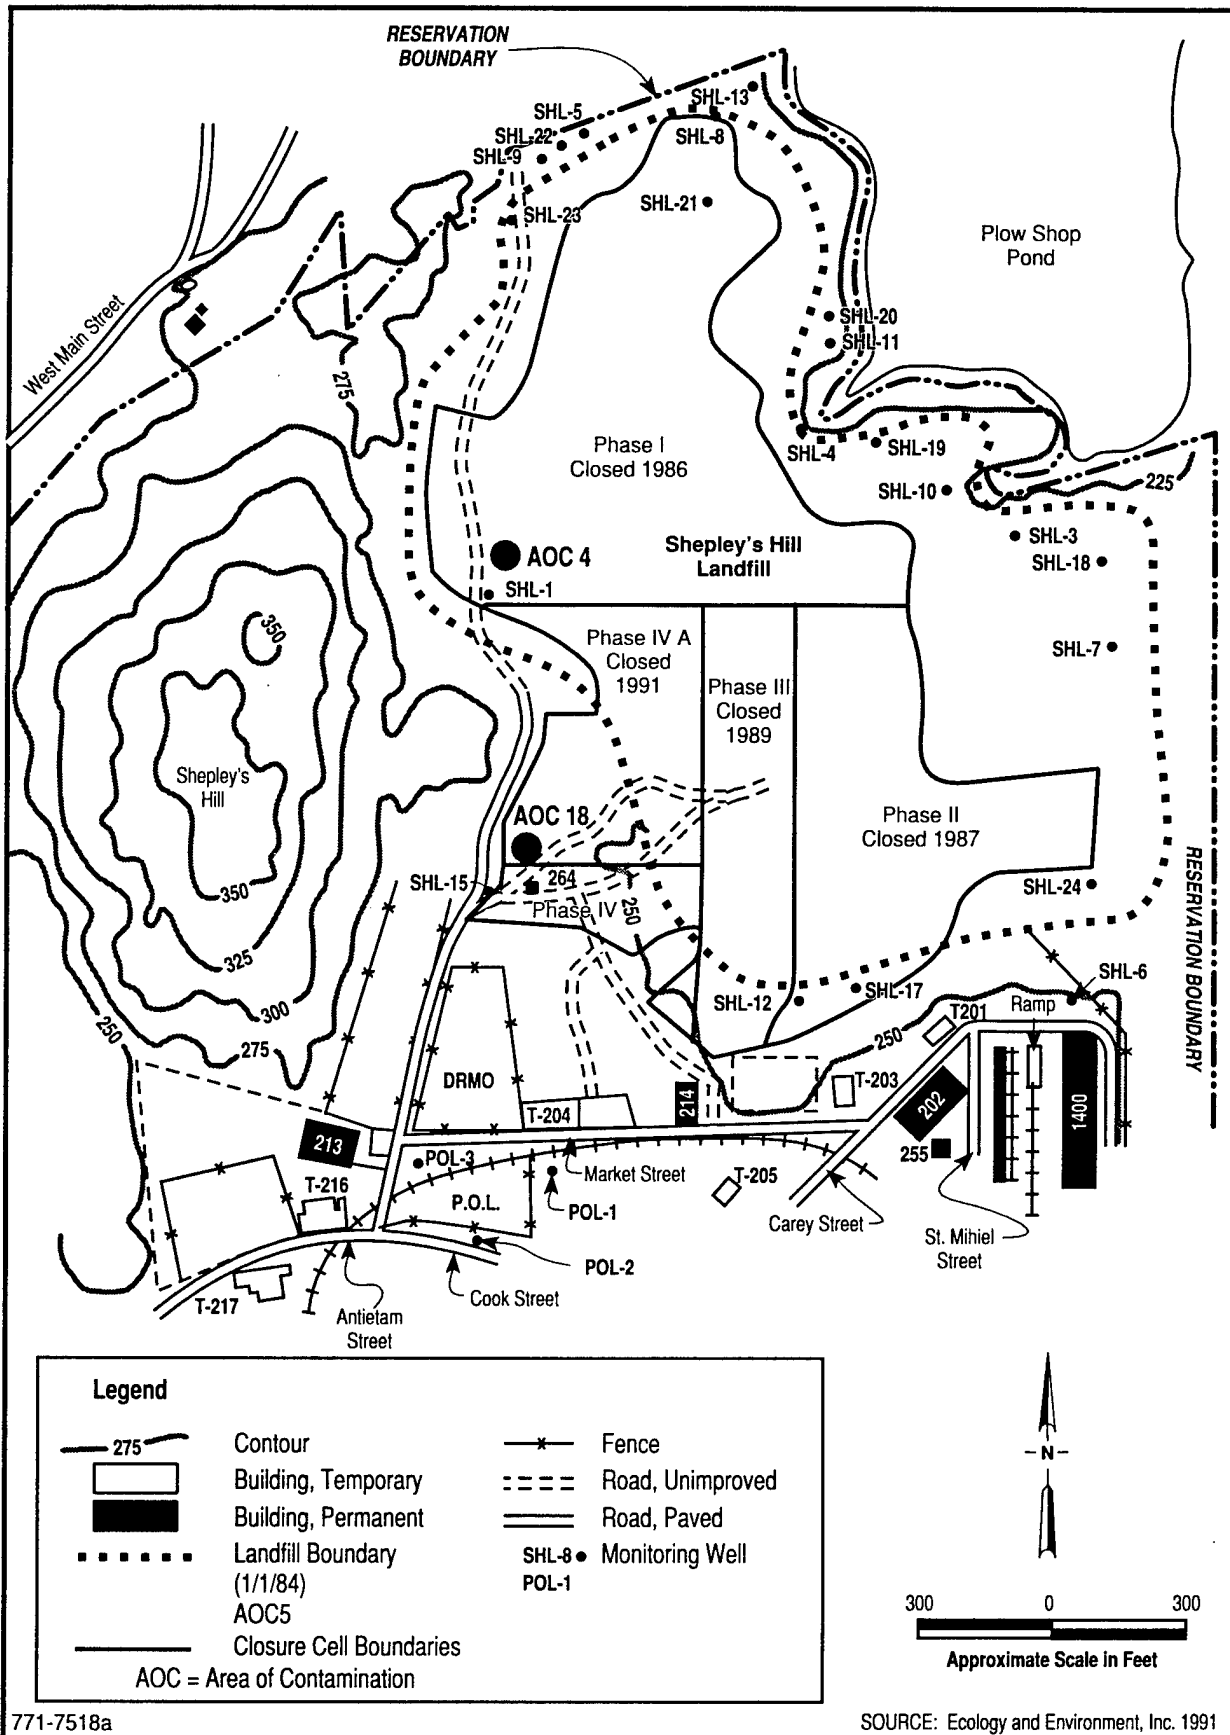
FIGURE 3-2 LOCATION OF SHEPLEY'S HILL LANDFILL (NO.1) INCLUDING FORMER SANITARY LANDFILL INCINERATOR AND THE ASBESTOS CELL

The landfill is operated using the modified trench method. There is evidence that more recent trenches in the northwest portion may have cut into previously used areas containing glass and spent shell casings. The glass dated from the mid-nineteenth century to as late as 1920. The total depth of the refuse is about 30 ft (DEH, 1985b).

The landfill site was probably selected because it was a wetland area and was an expedient choice for direct disposal of wastes. Information indicates that it was formerly operated as an open burning site. At a later time, waste was incinerated and the residue was buried. Con-Test (1989) reports that during a 1984 investigation, 40 test pits were excavated in various locations. An area of special concern was a location in the southeastern portion of the landfill reportedly used to dispose of flammable fluids. The report cited by Con-Test indicates that contamination was not substantiated by test pits or other research.

Fort Devens has an operating permit from the MDEP, and according to available information, the landfill is operating within these requirements. In an effort to abate the potential for off-site contaminant migration, Fort Devens initiated the Fort Devens Sanitary Landfill Closure Plan in 1984, in accordance with 310 CMR 19.00. The four-stage plan, written by Gale Engineering, was submitted to MDEP for review and approval. As part of a corrective action, the last section of the landfill was scheduled for closure in 1991 and an extension may allow operation into 1992; most of the landfill has already been closed (Figure 3-2). Fort Devens is coordinating the closure with MDEP authorities and is following an approved closure plan that includes regrading, gas ventilation, membrane capping, and a final vegetative cover. Some of the areas adjacent to Plow Shop Pond lie within the 100-year floodplain (Gale Engineering, 1985).

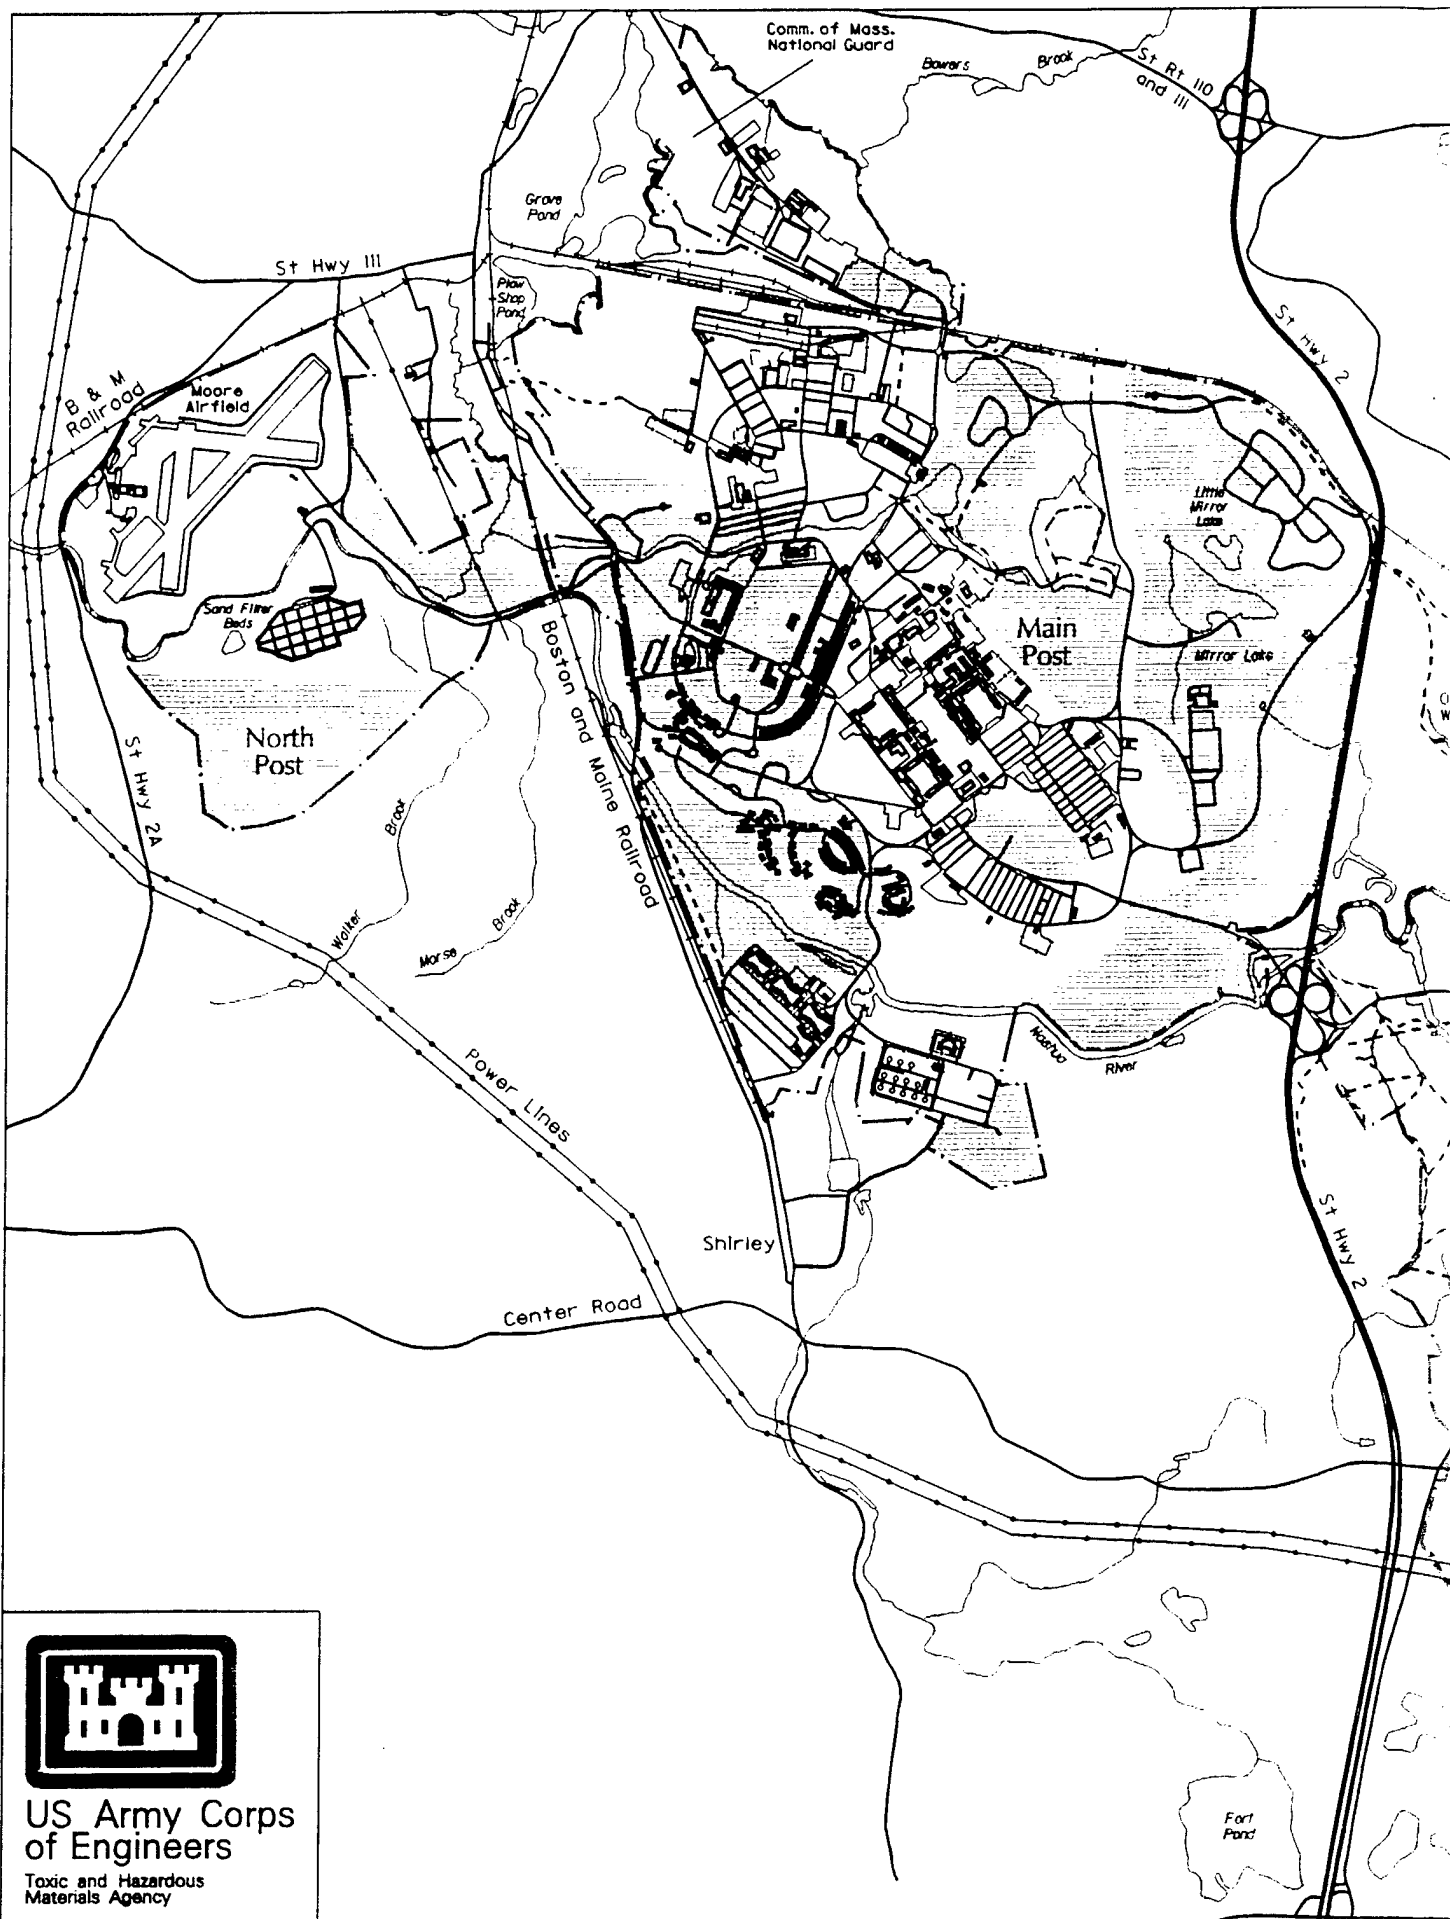
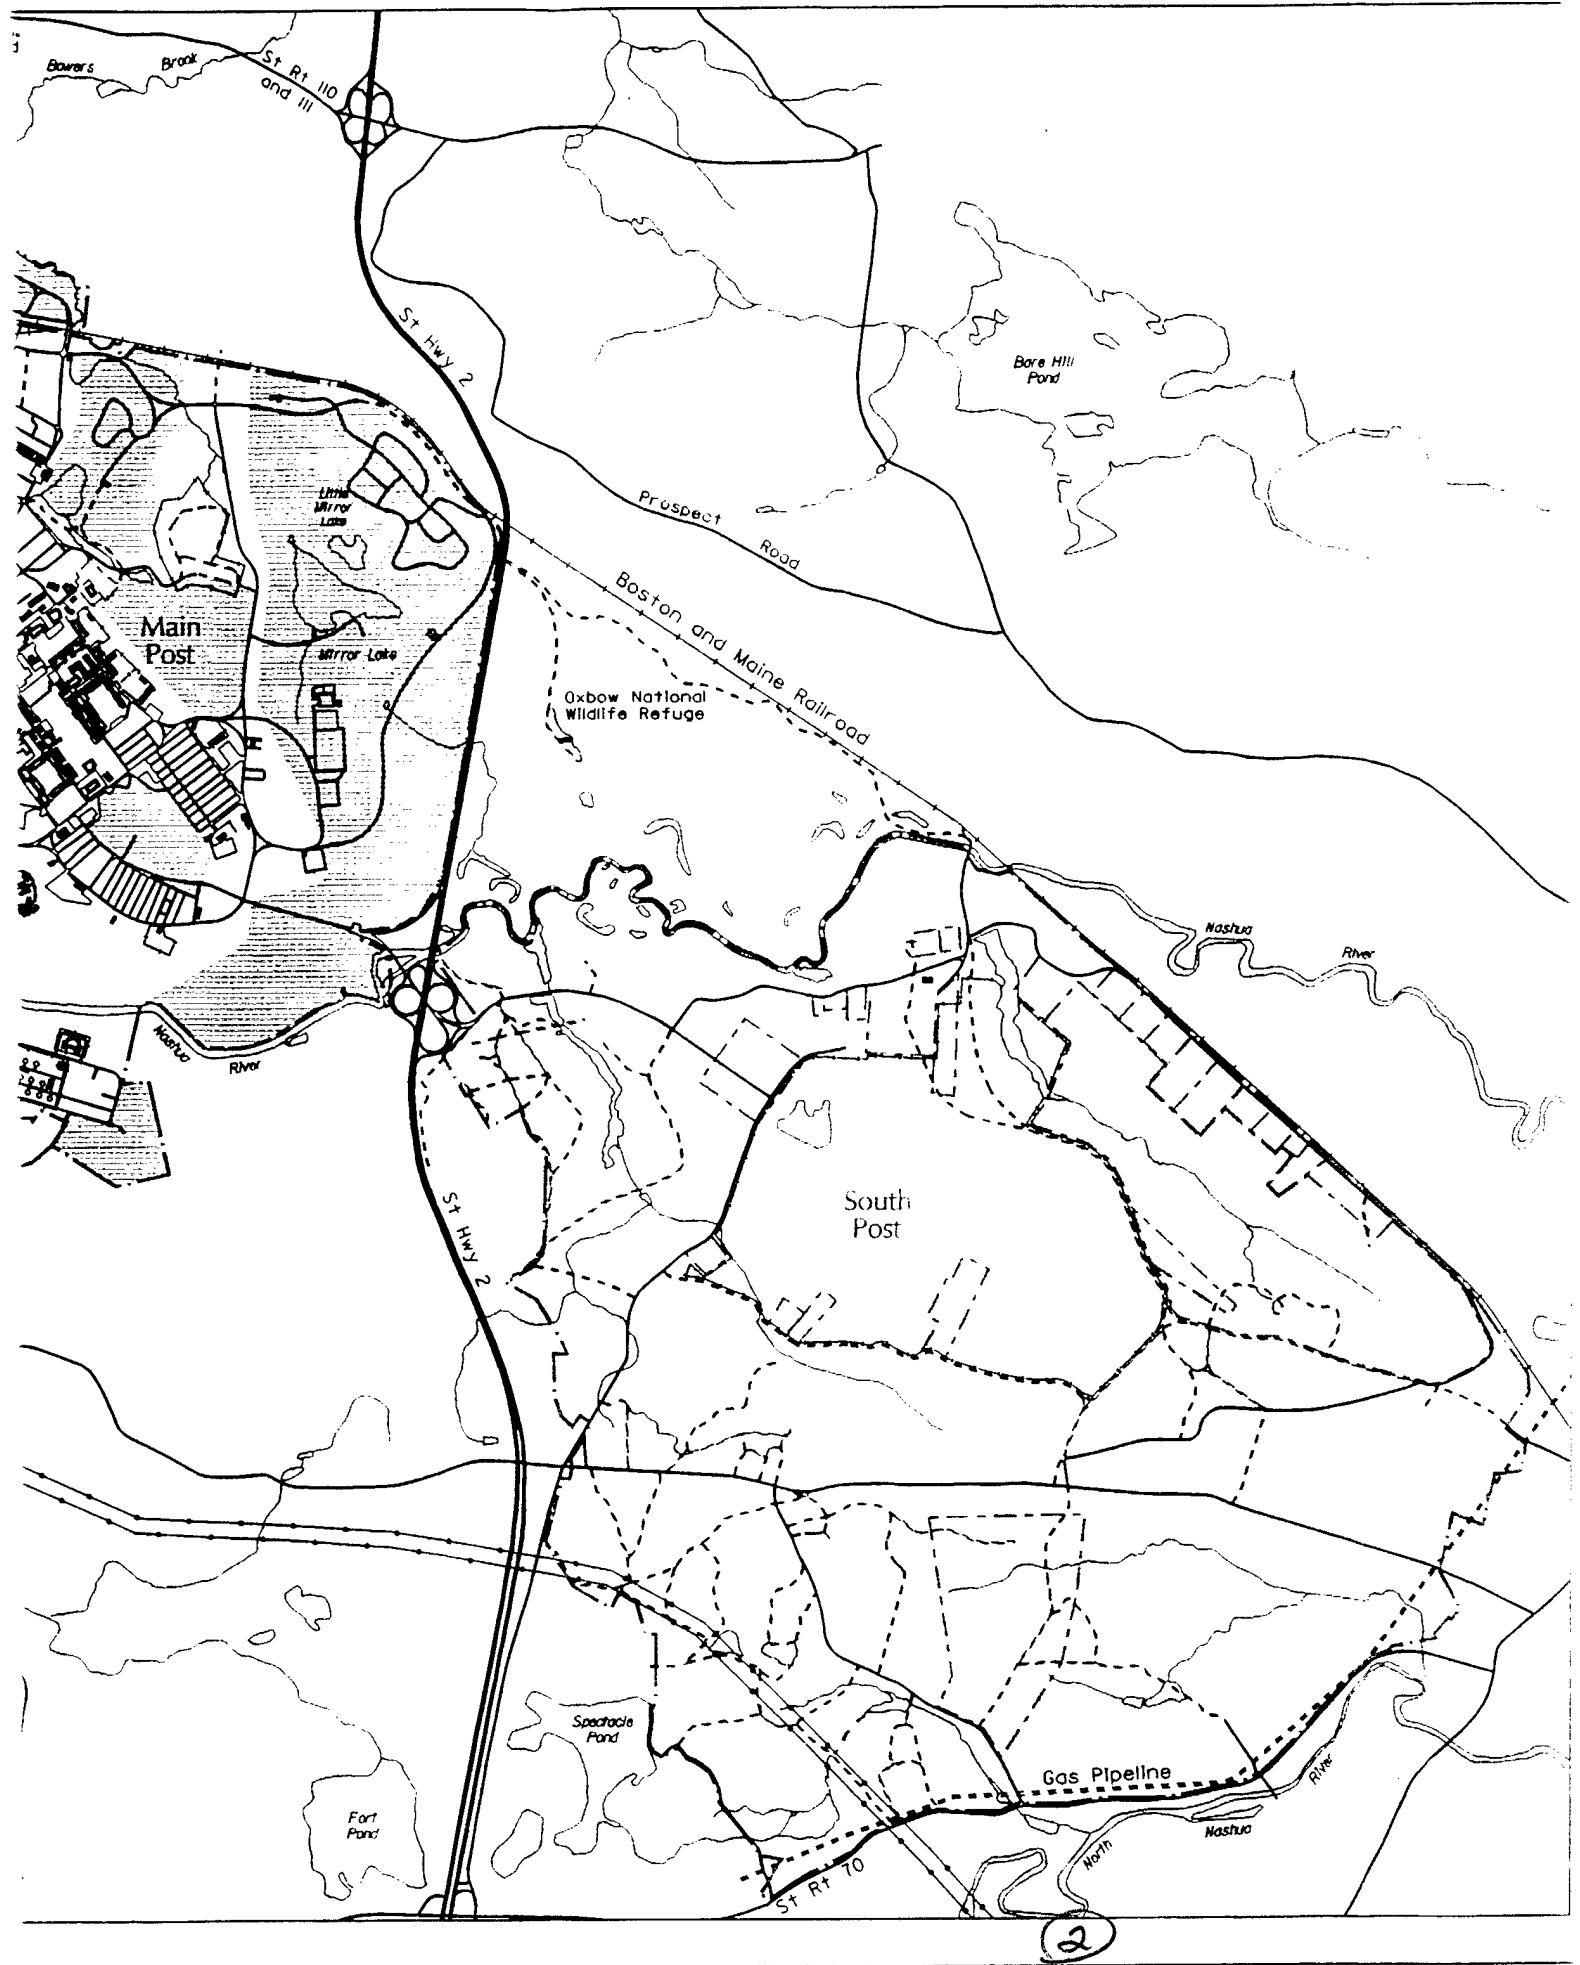
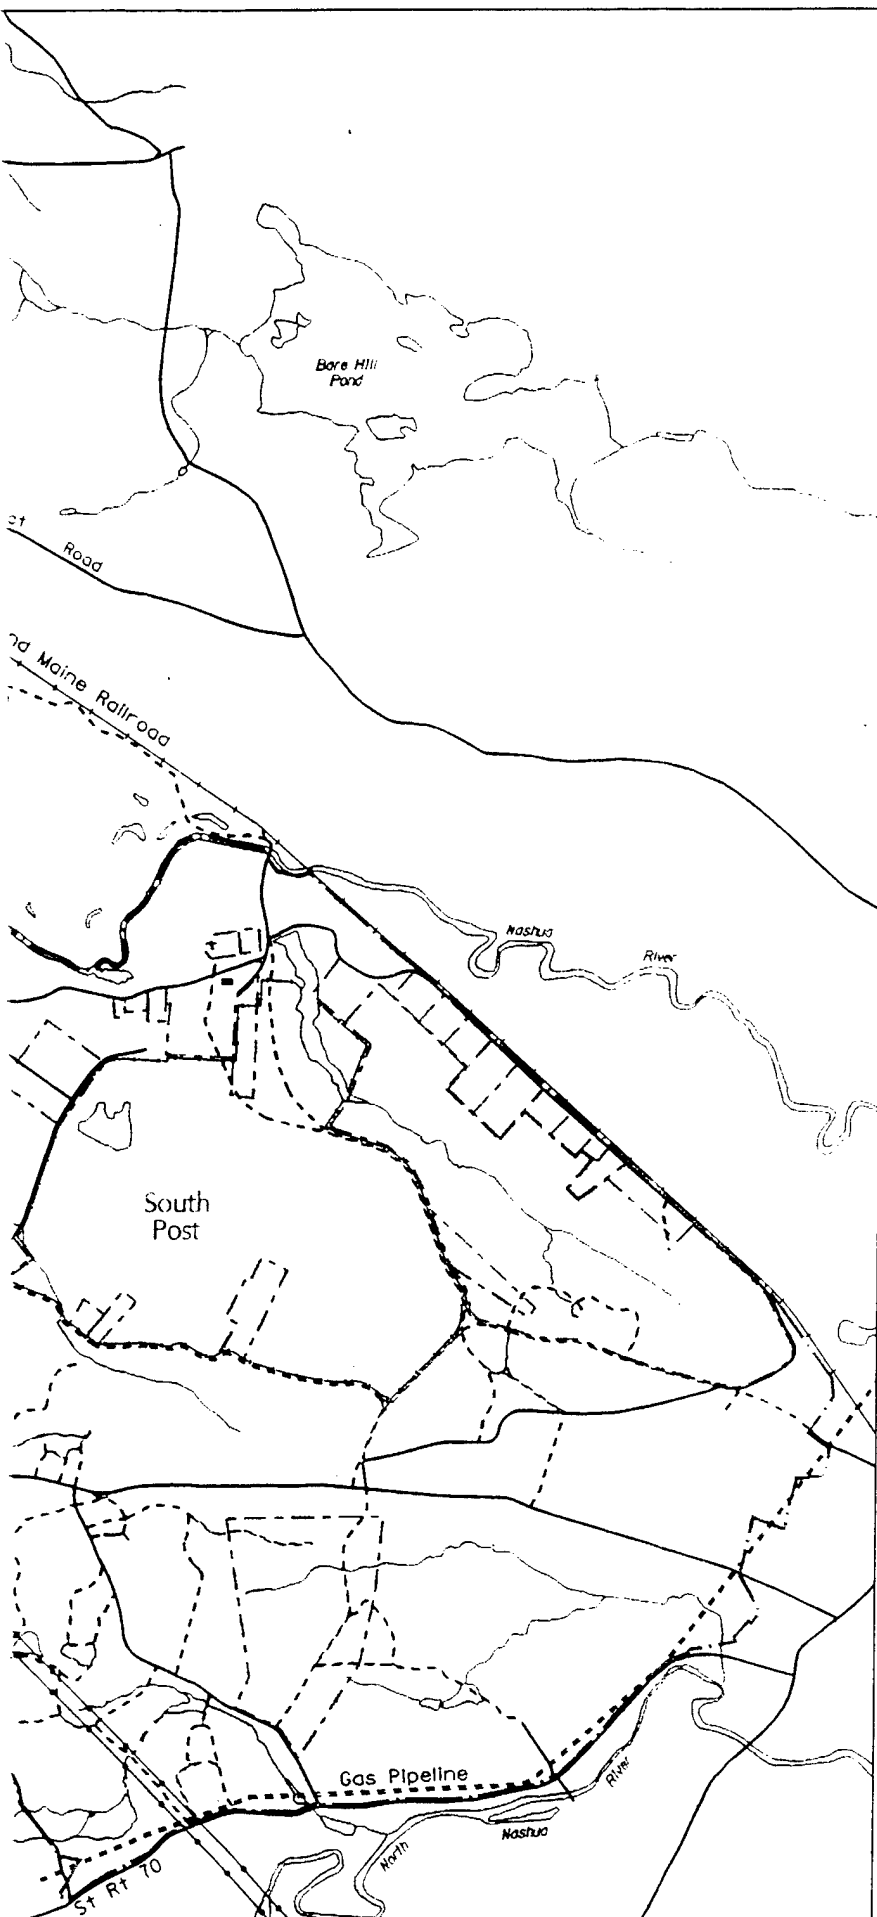
Figure 5-2 Areas with Minimal Potential for Environmental Problems

Based on WESTON's review of the available information, site visits, and interviews with facility personnel, those site areas that can potentially be excessed (undergo real estate transfer) with minimal additional environmental investigation have been identified. These site areas are included in Figure 5-2.

It should be noted that even though the above areas may have a minimal potential for environmental problems, the subsurface and/or groundwater could be contaminated by operations adjacent to or upgradient of these areas, and that the scope of WESTON's work included no actual sampling of environmental media.

Many buildings, such as schools, the day care center, and administration buildings, may be excessed with a minimum of additional investigation, including but not limited to asbestos, radon, and lead paint surveys and sampling.

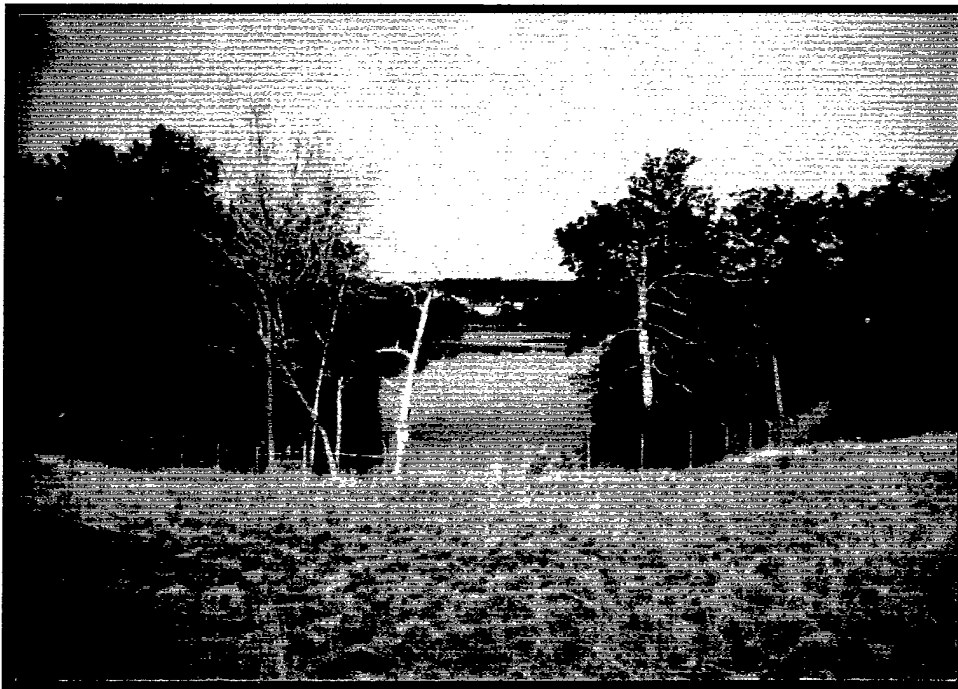
**2. AREE 5 - SHEPLEY'S HILL LANDFILL (NO.1) (FOREGROUND) AND
LEACHATE DISCHARGE POINT IN PLOW SHOP POND (BACKGROUND)**

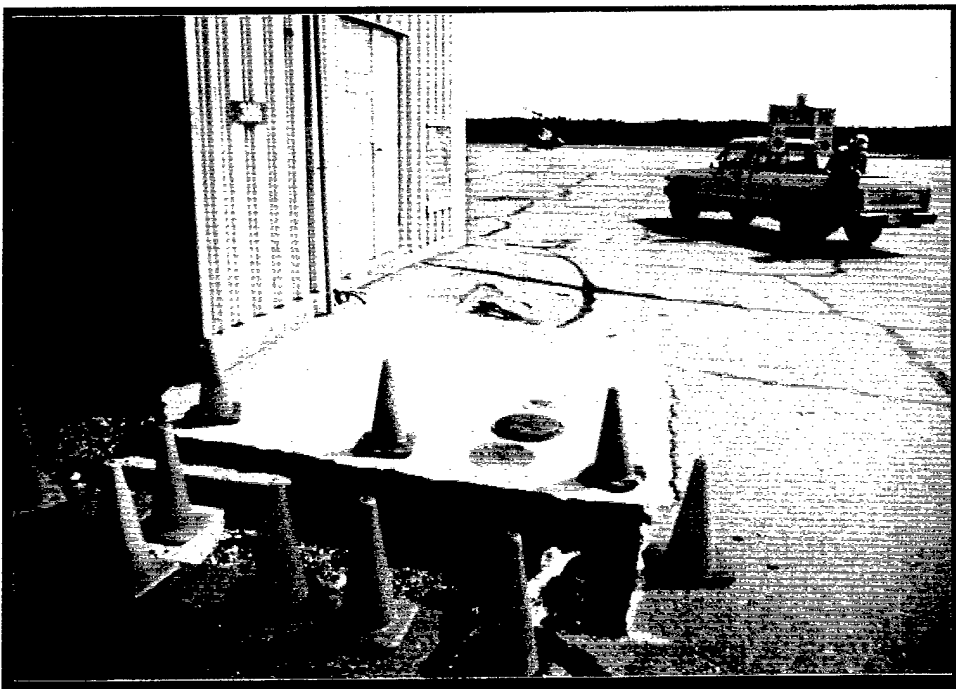
18. AREE 31 - FORMER FIRE-FIGHTING TRAINING AREA AT MAAF

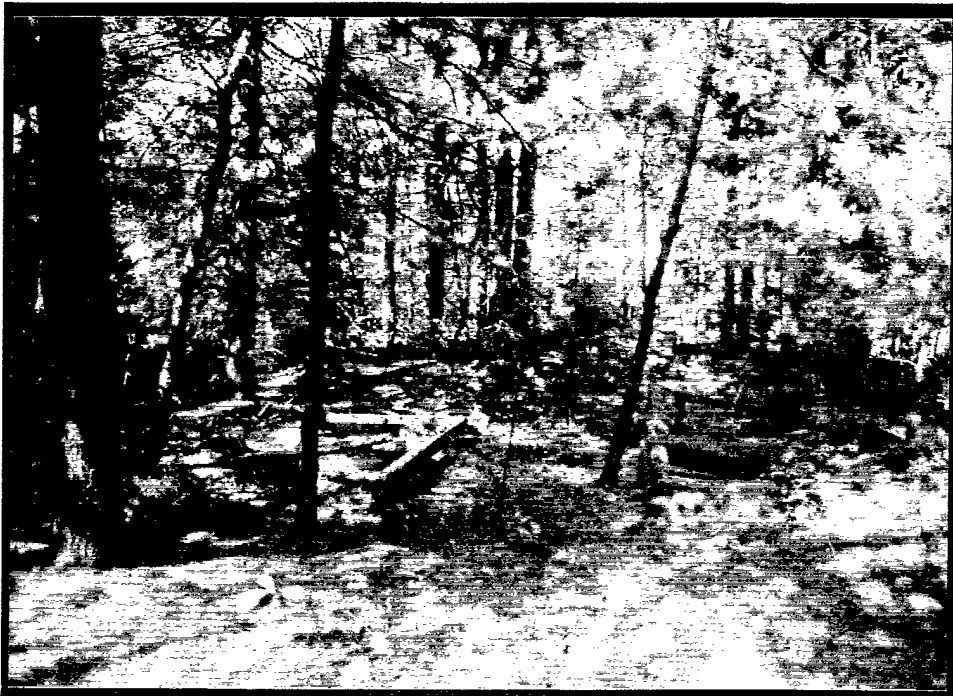
19. AREE 47 - FORMER LUST SITE AT MAAF (BUILDING 3816)
